SUMMARY REPORT
GROUND PROJECT SURVEYS
FOR THE QUARTER ENDED
DECEMBER 31, 2005

SIGIR PA-06-048
APRIL 13, 2006

SUBJECT: Summary Assessment Report of Ground Project Surveys for the Quarter
Ended 31 December 2005 (Report Number SIGIR-PA-06-048)

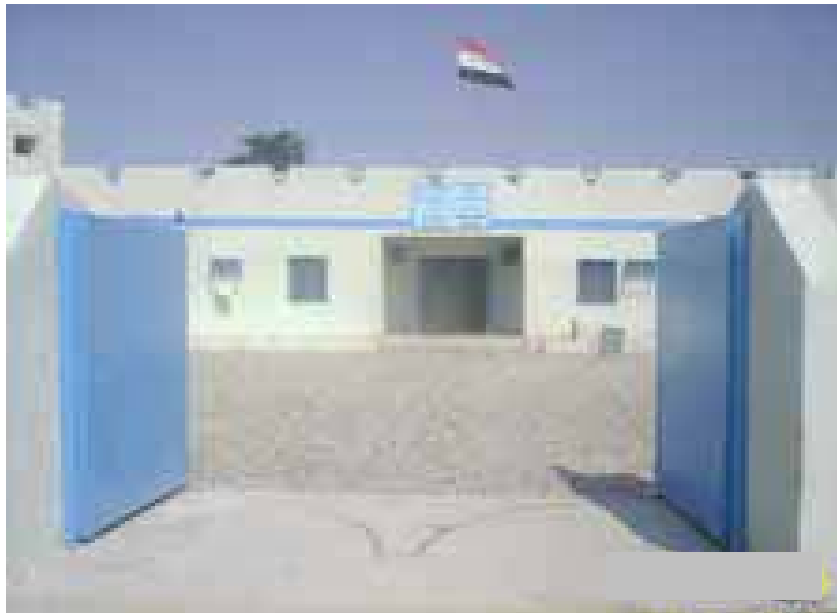
A review of the report and photos provided by the QCQA teams determined that overall, the site associated with Task Order 0034, Project 12161, appeared to be complete and consistent with contract requirements. A perimeter wall surrounded the post, containing the parking area and above ground fuel tank. In addition, there were security bars on the first floor windows and a security cage enclosed the generators. The site also contained above ground water tanks, set on a concrete base, with additional water tanks located on the roof. A septic tank appeared to be located between the berm and outer wall of the post. Site Photo 3 shows the front gate and border post.

Site Photo 3: Front entrance gate and border post Project 12161

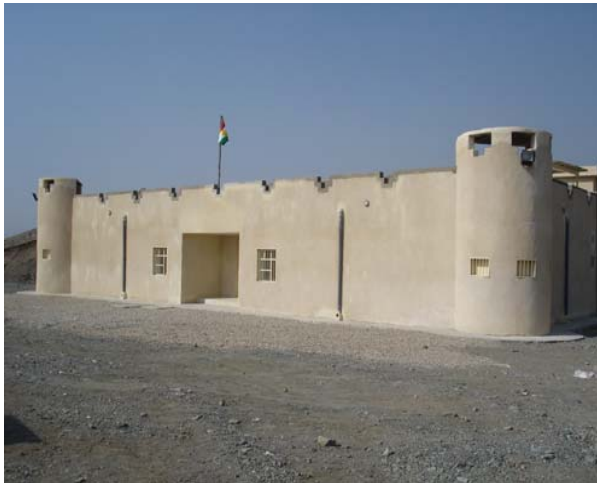
- No perimeter security fences or gates were present. Site Photo 6 shows the front view of project 12840.
- Concrete on the atrium roof showed inconsistent textures, possibly the result of non-continuous pour. Site Photo 7 shows the atrium concrete roof.
- Spot welds on the generator roofing appeared to be poor quality.

Site Photo 6: Front view of Project 12840

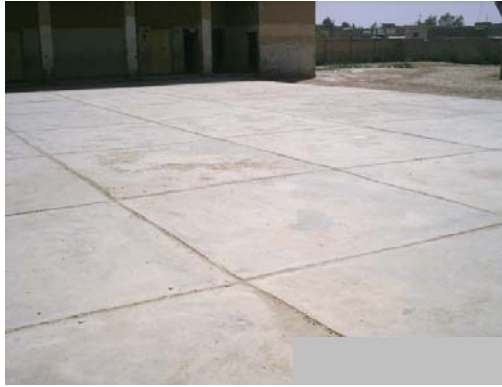
With the possible exception of a new concrete area outside, recent renovations were not obvious. Site Photo 15 shows the concrete courtyard area. We noted the following discrepancies:

Site Photo 15: Concrete courtyard at Project 10630

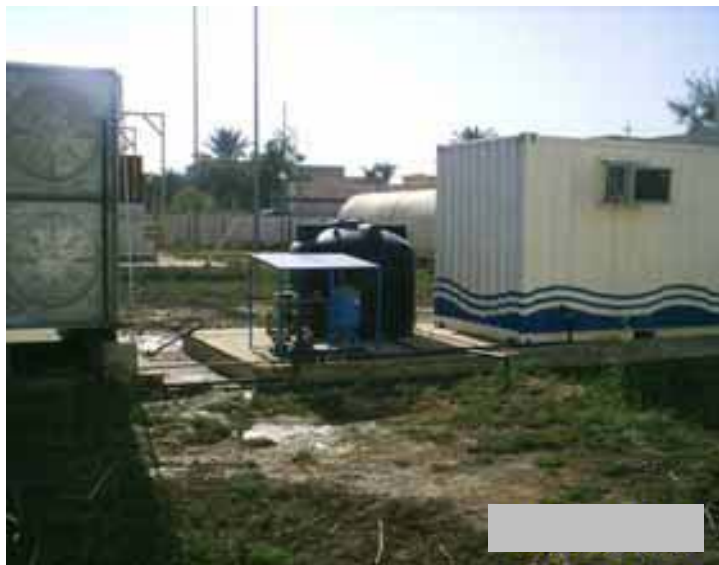
This building appeared to be an existing structure with renovations on going at the time of the site visit. A new reverse osmosis water purification unit, medical incinerator, and two generators were observed at the facility. Site Photo 19 shows the containerized reverse osmosis water purification unit with exterior pumps and water tanks. Renovation had not begun or was only partially complete on the plumbing, fixtures, electrical, and waste water systems. Observations during the site visit were:

- The interior finish is poor in some areas and there is staining on the ceiling and floors indicating water leakage either from pipes or from the roof. The floors require repair before tiling can be completed.
- New electrical boards are on site but not installed. Power cables were inappropriately passed through a window into the electrical room.

Site Photo 19: Containerized reverse osmosis unit with exterior pumps and storage tanks at Project 1270

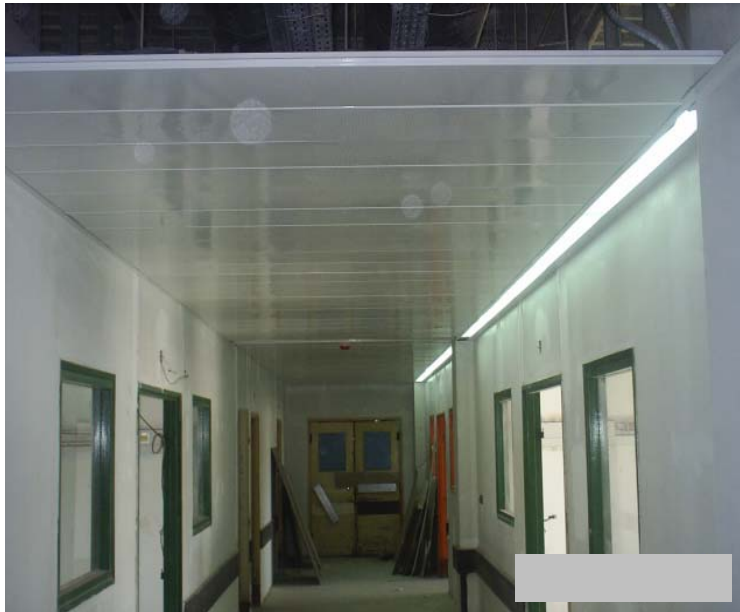
throughout the facility. Site Photo 20 shows a renovated hallway. Construction of a new sewer is underway; however, there were concerns about the elevated groundwater level and the direction of drainage relative to the road.

Site Photo 20: Renovated hallway at Project 10318

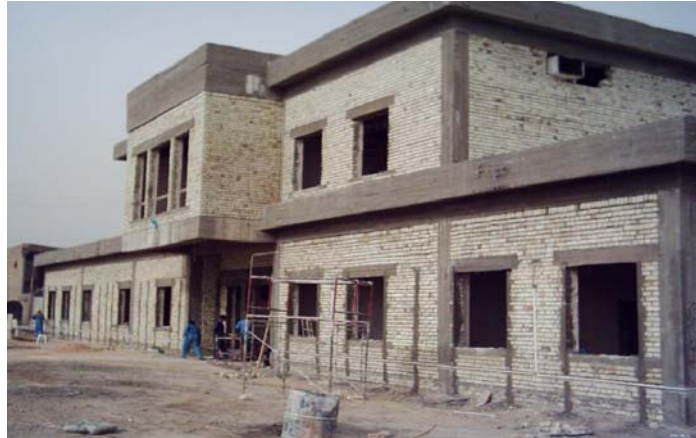
The site visit verified construction was in-progress. The structural concrete columns, beams, and slabs appeared complete. Site Photo 21 shows front exterior of the clinic. Brickwork for the exterior walls appeared completed with external plastering initiated. Installation of mechanical ductwork was complete and installation of electrical wiring was in-progress.

Site Photo 21: Exterior front of Project 11897

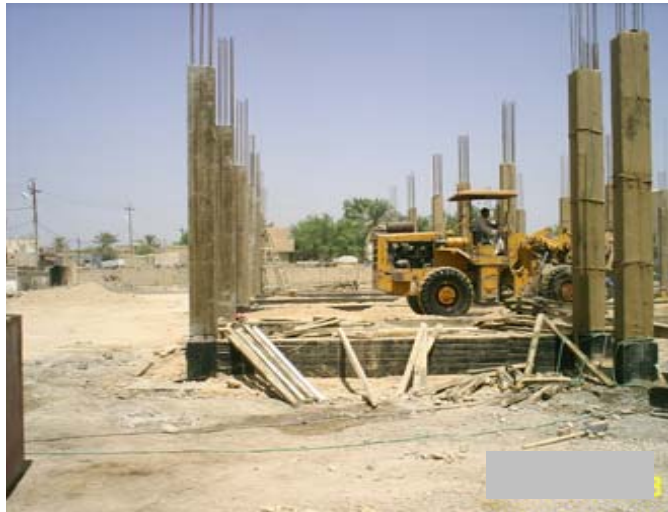
The project was in-progress at the time of the site visit. The QCQA teams observed completed concrete footers and ground level reinforced concrete columns. Burlap surrounded several columns, presumably used to keep the surface moist for curing purposes. Several construction workers were on site during the site visit. Site Photo 22 shows construction of columns and footers.

Site Photo 22: Construction of columns and footers at Project 11941

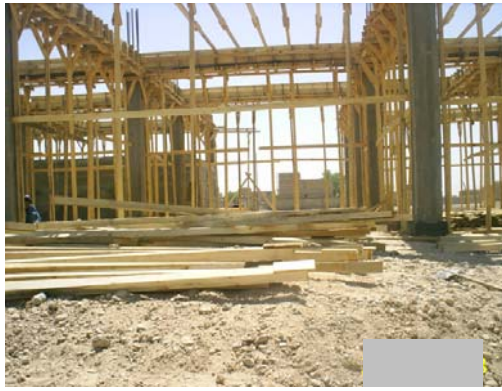
During the site visit new construction was in-progress. Concrete footers and ground level concrete reinforced columns appeared to be complete. Form work for the concrete reinforced beams were in place, although it could not be determined if the concrete beams had been poured. Concrete column surfaces appeared free of segregation. Rebar and crushed aggregate, both coarse and fine, were observed stockpiled on site. Site Photo 23 shows form work and Site Photo 24 shows aggregate stockpiled at Project 11943.

Site Photo 23: Form work at Project 11943

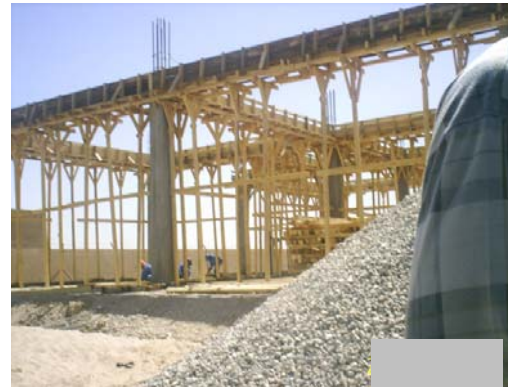
Site Photo 24: Aggregate stockpile at Project 11943

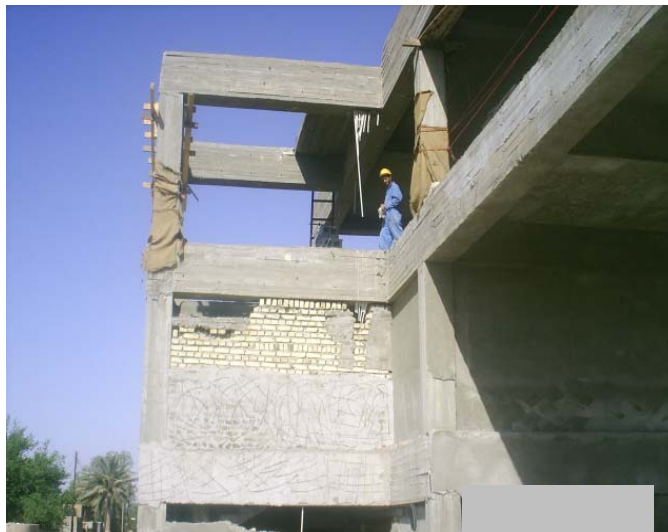
Construction of the facility was on-going at the time of the site visit. The QCQA team observed constructed structural concrete columns, beams, and elevated slabs on the ground, first, and second floor. Several columns were wrapped with burlap, presumably for curing purposes. Review of photos showed no areas of segregation, although we did not document the entire facility. Interior and exterior block walls were partially complete with external plastering in progress. Installation of window frames on the first floor rear of the building was on-going. We noted no discrepancies. Site Photo 25 shows Project 10072 under construction.

Site Photo 25: Project 10072 under construction

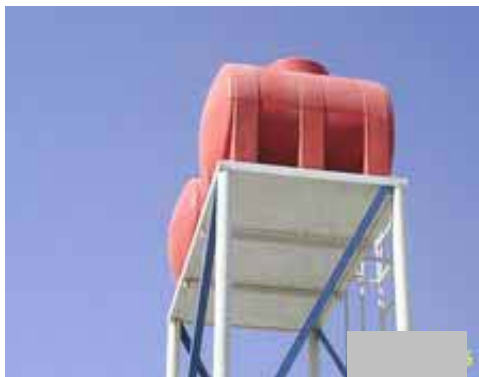
Site Photo 30: Water tanks installed on tower at Project 18243

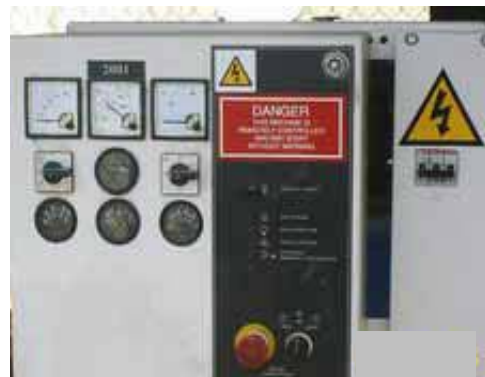
The IRMS database listed the project as 100 percent complete on 3 May 2005. The site contained a perimeter security wall and gates, along with a generator with what appeared to be a correctly installed modern circuit breaker box and system. The site also contained a completed steel frame constructed parking area with a corrugated roof and elevated water tanks located on the roof on top of a tower. We observed some deterioration of plastering on exterior surfaces of the facility but did not note any significant deficiencies. Site Photo 30 shows water tanks installed on towers and Site Photo 31 shows the generator electrical panel at Project 18243.

Site Photo 31: Generator electrical panel at Project 18243

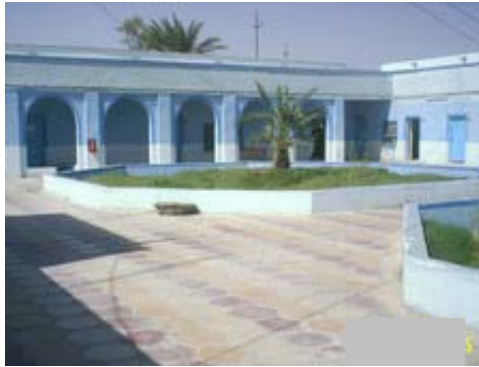
The IRMS database listed the project as 100 percent complete on 5 June 2005. The project specific Bill of Quantity was not available for review. Good quality work was apparent in the courtyard area. Site Photo 32 shows the courtyard. Deficiencies noted were:

Site Photo 32: Courtyard at Project 18248

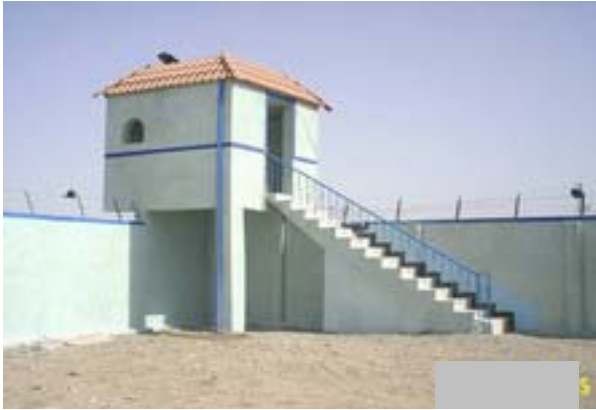
The IRMS database listed the project as 100 percent complete on 15 June 2005. A perimeter security wall with concertina wire, entrance gates, and guard towers was located on site. Site Photo 34 shows the perimeter security wall with a guard tower. The site also contained a covered 6-bay parking area and water tanks with a small installed pump. In addition, a central courtyard, constructed of a concrete pad and tiles, was located near the entrance of the main building. Deficiencies noted were:

Site Photo 34: Perimeter Security wall with concertina wire and guard post at Project 18268

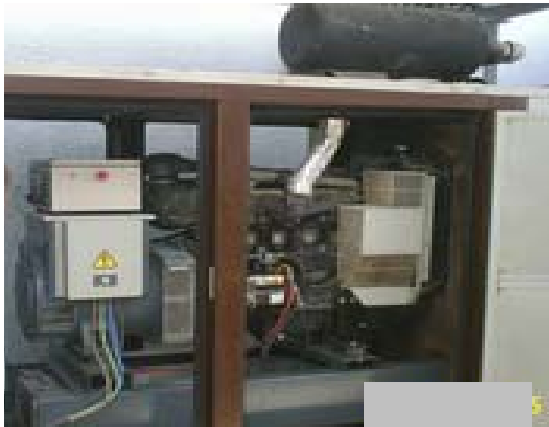
The IRMS database listed the project as 100 percent complete on 10 June 2005. The facility contained a 50 kVA generator, a covered parking area, and water tanks, which were consistent with contract requirements. Site Photo 36 shows the generator. Deficiencies noted were:

Site Photo 36: Generator at Project 18273

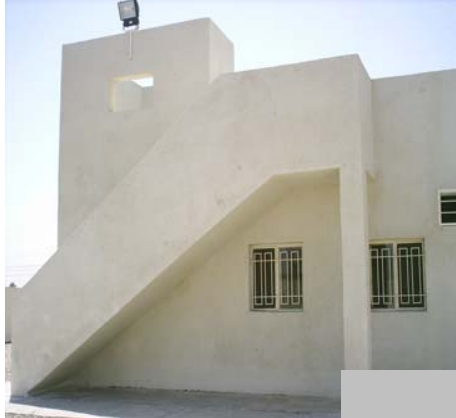
The IRMS database listed the project as 91 percent complete on 10 September 2005. A new or recently renovated building with sidewalks, security walls, security lighting and gates was at the location. Numerous checkpoint facilities were located outside the perimeter of the facility. In addition, a generator and a fuel tank were on site. The quality of construction appeared very good and we noted no discrepancies. Site Photo 40 shows the exterior of the building and Site Photo 41 shows the checkpoints at Project 19218.

Site Photo 40: Exterior of building at Project 19218

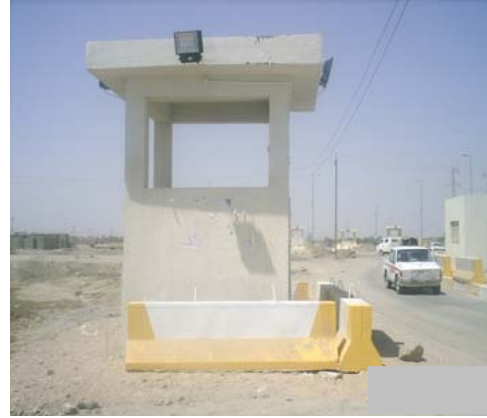
Site Photo 41: Checkpoint at Project 19218

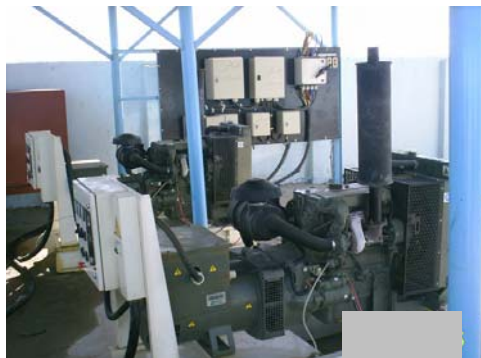
The IRMS database listed the project as 100 percent complete on 21 July 2005. The facility appeared to be new construction and consisted of a building, perimeter security wall, guard posts and checkpoint guardhouses. External security lighting was present, and two 30 kVA generators with fuel tanks were located on site. Site Photo 42 shows the two generators located on site. Deficiencies noted were:

Site Photo 42: Two 30 kVA generators at Project 19220

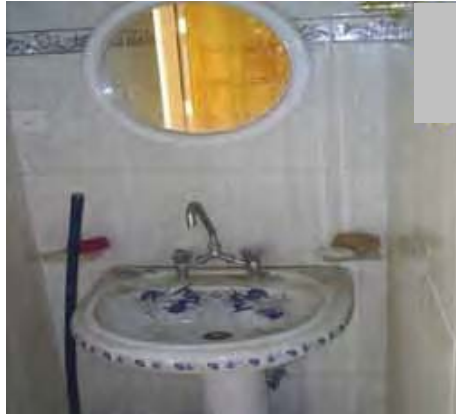
The IRMS database listed the project as 100 percent complete on 20 August 2005. The construction appeared complete at the time of the site visit. The site contained perimeter security walls with entrance gates and the main building included guard towers and security lighting. Two 30 kVA generators were located on site. Nine security checkpoints with jersey barriers were located outside of the perimeter walls along the roadway. The quality of materials was good, and the installation of the plumbing and tile appeared professional. The QCQA team learned during the site visit that there were some problems with the generator and external lighting. Site Photo 44 shows interior bathroom fixtures and Site Photo 45 shows tile work at Project 19221.

Site Photo 44: Interior bathroom fixtures at Project 19221

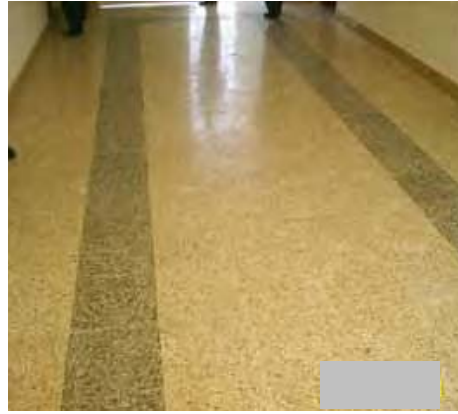
Site Photo 45: Interior tiles at Project 19221

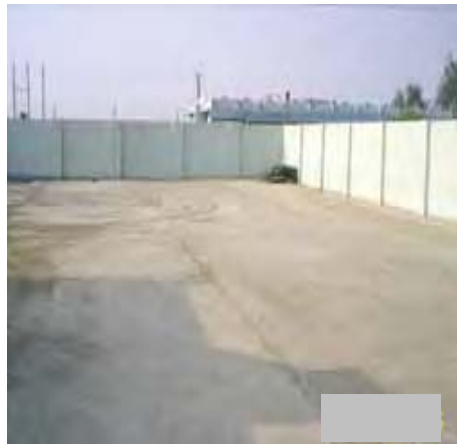
The IRMS database listed the project as 100 percent complete on 9 June 2005. A concrete slab parking area was located within the perimeter and surrounded the facility. Site Photo 48 shows the perimeter security wall and concrete pad. A generator and fuel storage tank were also located on site. Deficiencies noted were:

Site Photo 48: Perimeter security wall and concrete pad at Project 19223

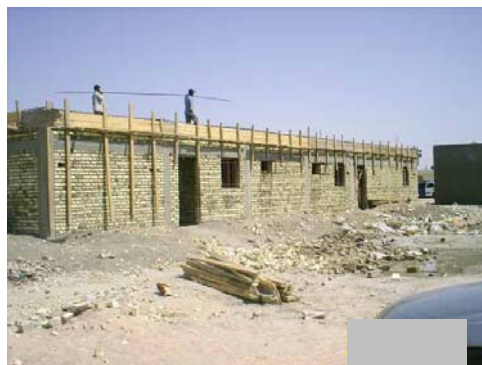
The IRMS database listed the project as 68 percent complete on 10 September 2005. New construction and renovation of buildings was in progress at the time of the site visit. Buildings were in different stages of completion from initial framing to nearly complete. The perimeter appeared complete with concertina wire, entrance gates, and guard towers. Several buildings showed installation of interior electrical components and lights, although the electrical system was not completed. We did not note any significant deficiencies. Site Photo 52 shows a building under construction and Site Photo 53 shows the perimeter security wall and guard tower at Project 20347.

Site Photo 52: Building under construction at Project 20347

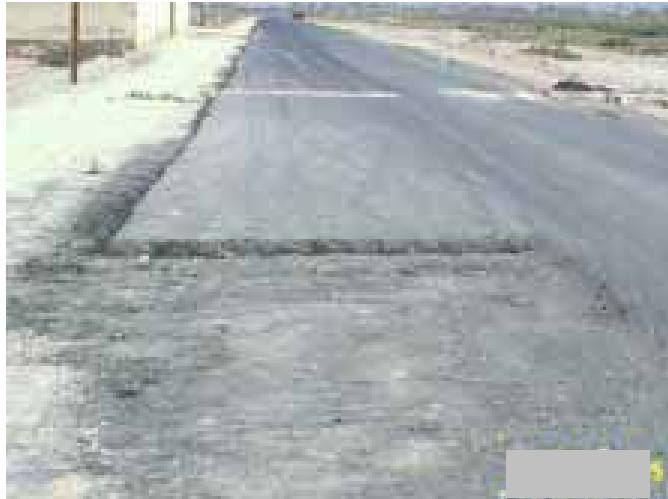
Site Photo 54: Asphalt surface of Project 17783

The survey team verified that road construction was in progress at the time of the visit. Installation of the sub base and asphalt surface appeared to be consistent with the design requirements. Additional road surface and shoulder work was still required at the time of the visit. We did not note any major discrepancies. Site Photo 54 shows the asphalt road at Project 17783.

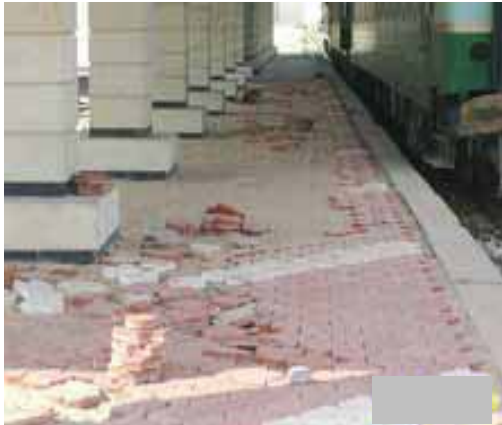
Site Photo 56: Installation of brickwork at Project 21251

The renovation project was in-progress at the time of the survey site visit. Placement of exterior patio brick over sand base was partially complete. Site Photo 56 shows the brick installation. The survey team observed brick and cement manholes and trenches between the manholes. Site Photo 57 shows manholes under construction. Minor electrical work had also begun. Discrepancies noted were:

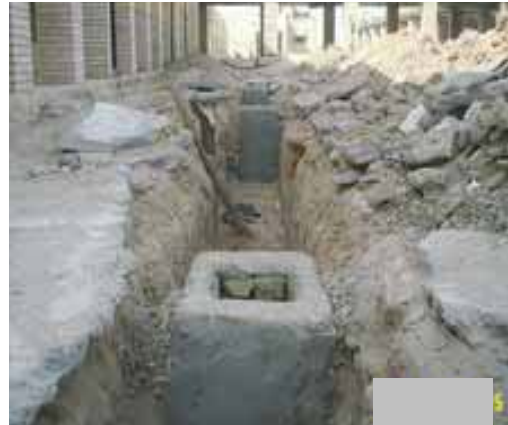
Site Photo 57: Manholes and excavation at Project 21251

- Manholes appeared to be of poor quality.
